Maryland Inventory of Historic Properties  
Historic Bridge Inventory  
Maryland State Highway Administration  
Maryland Historical Trust

MHT Number AL-V-B-308

Name and SHA No. Locust Grove Road over Wills Creek/A6310

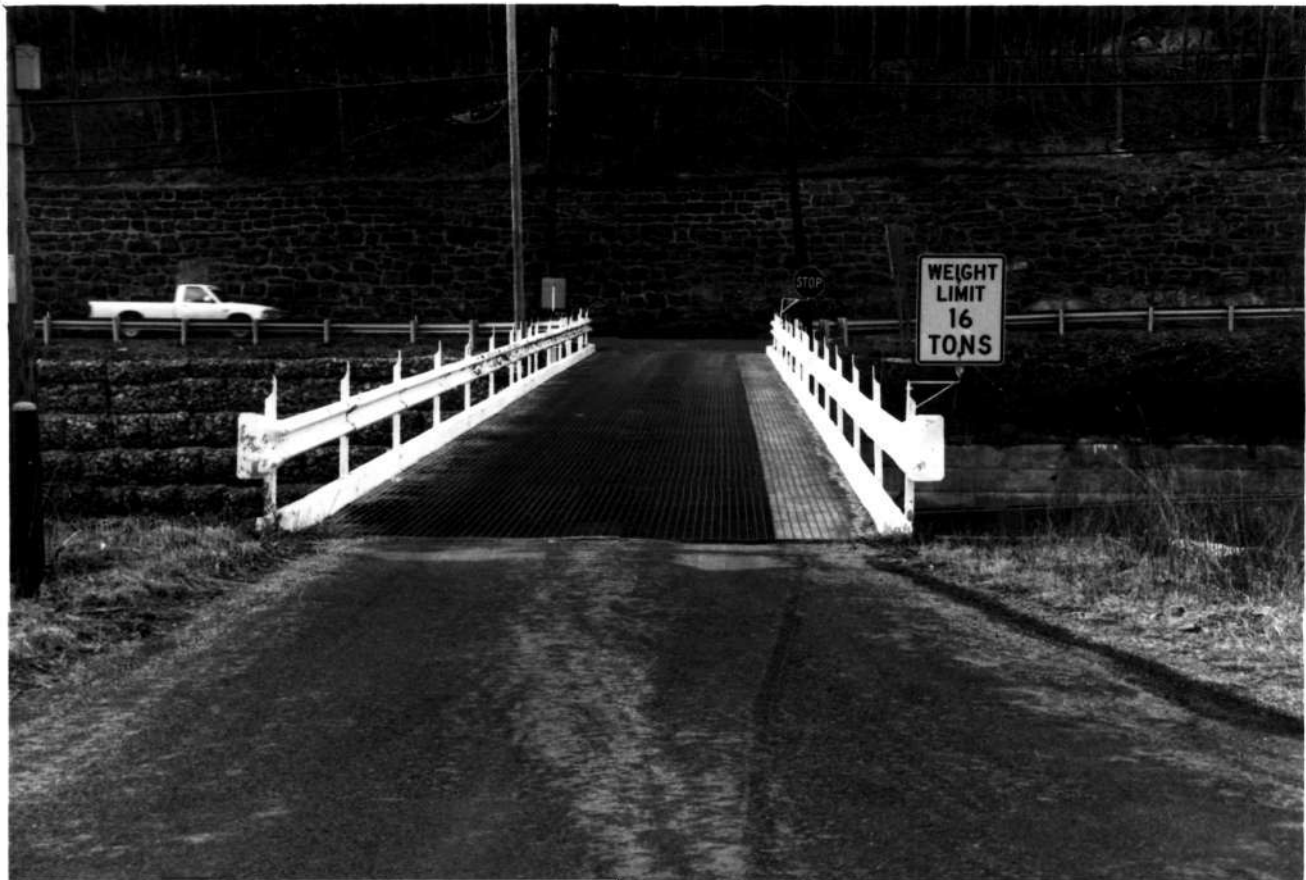
1 OF 5

WEST APPROACH

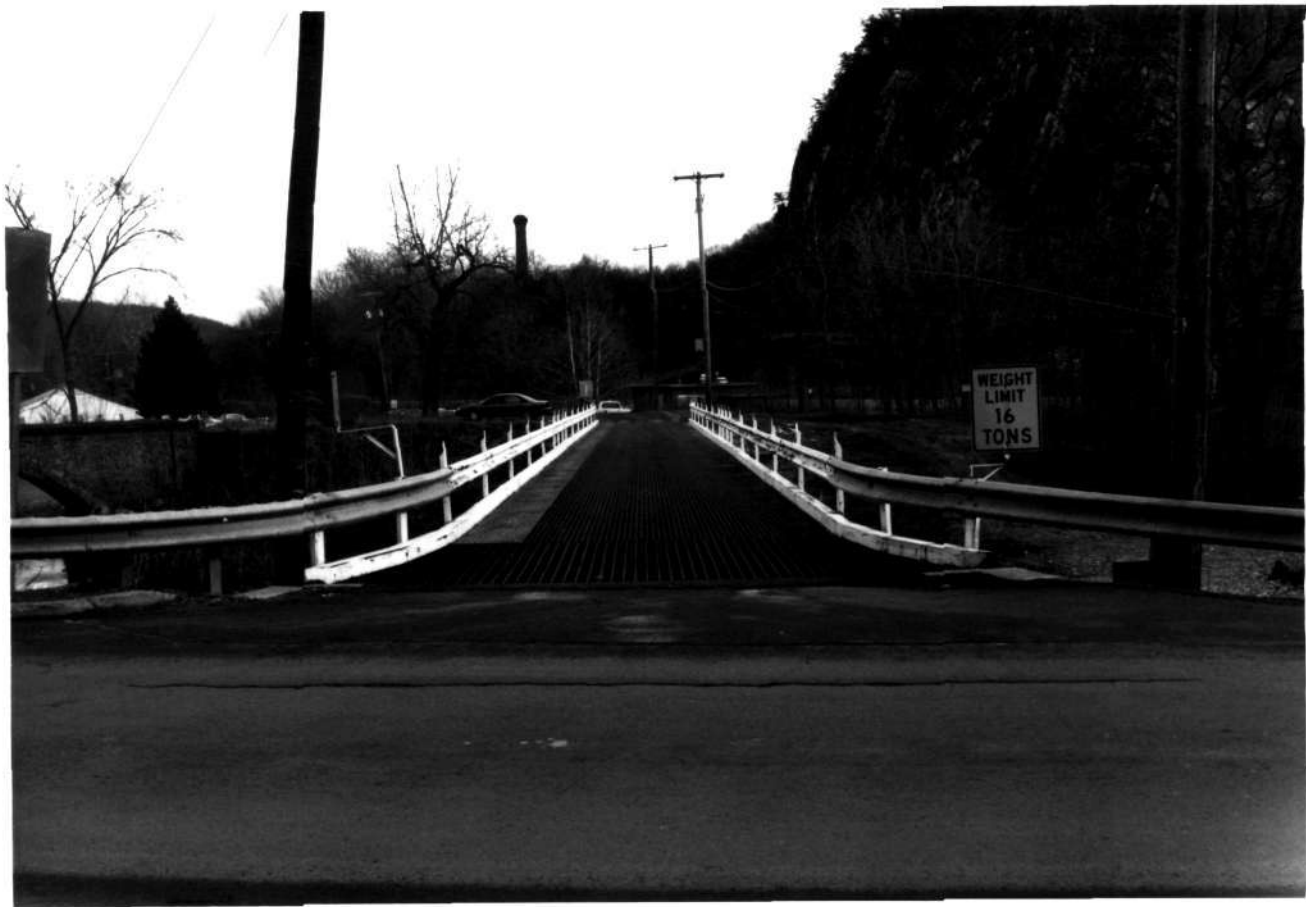
2 OF 5

EAST APPROACH

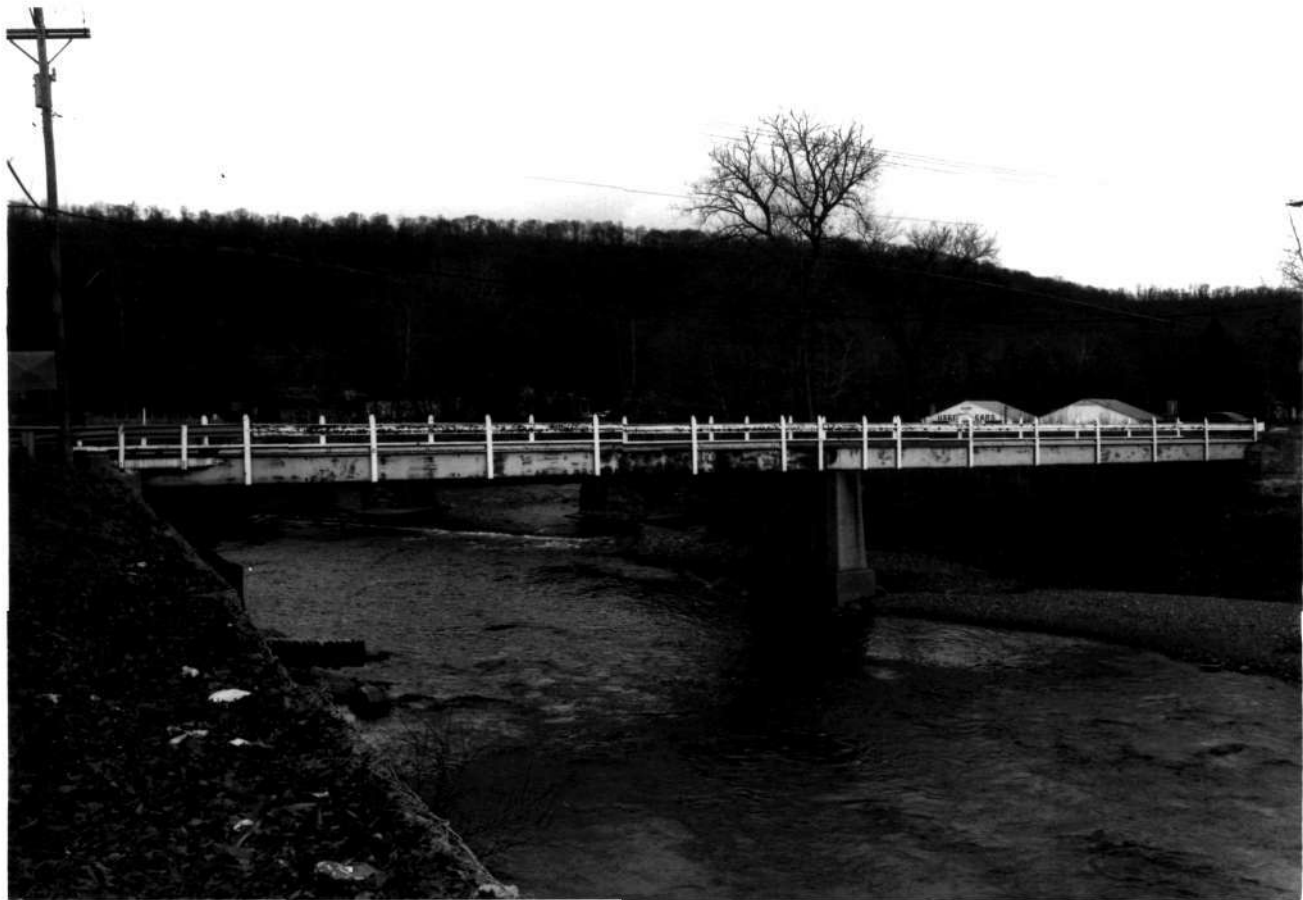
3 OF 5

NORTH ELEVATION (DOWNSTREAM)

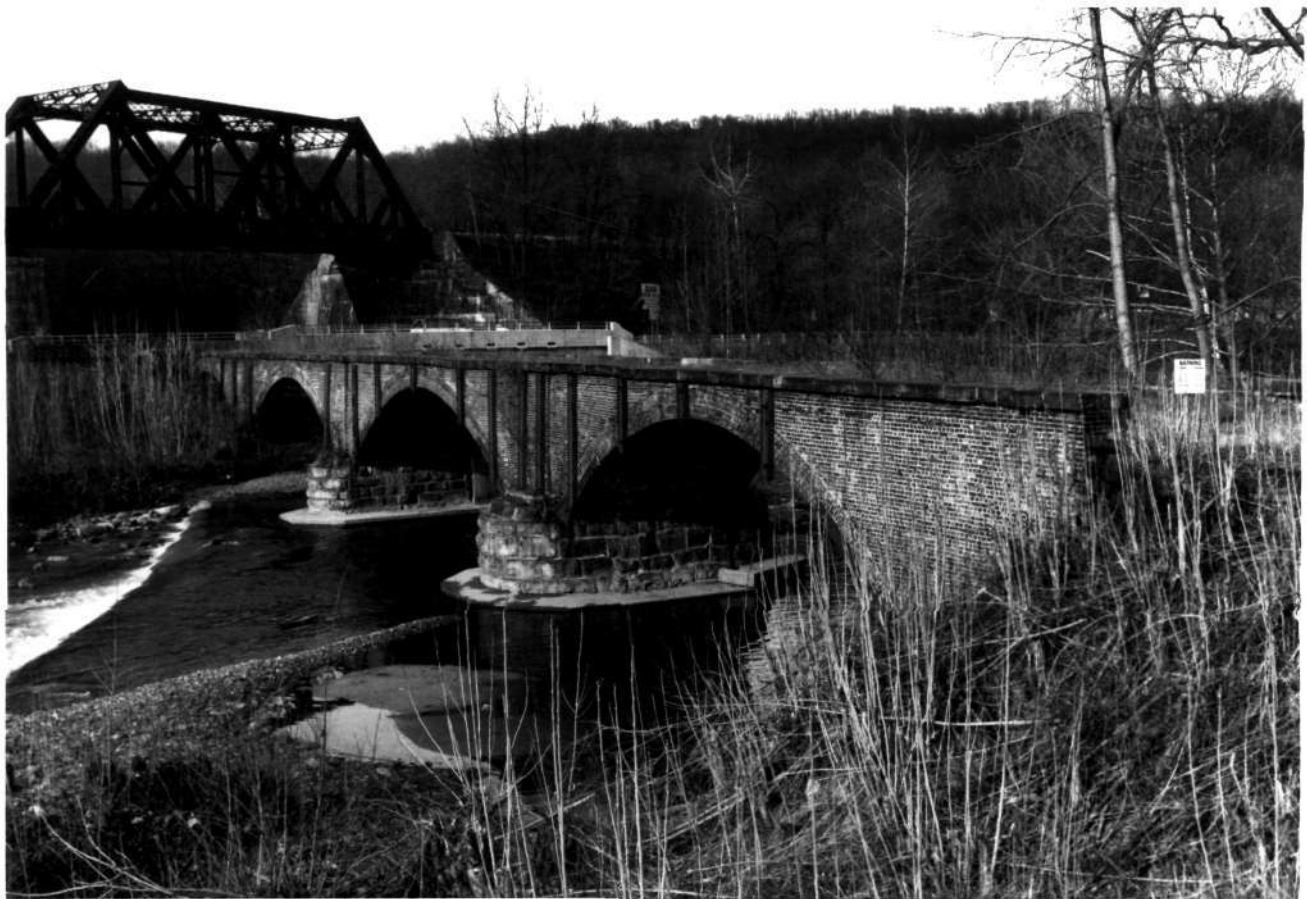
4 OF 5

CLOSED BRIDGE TO SOUTH

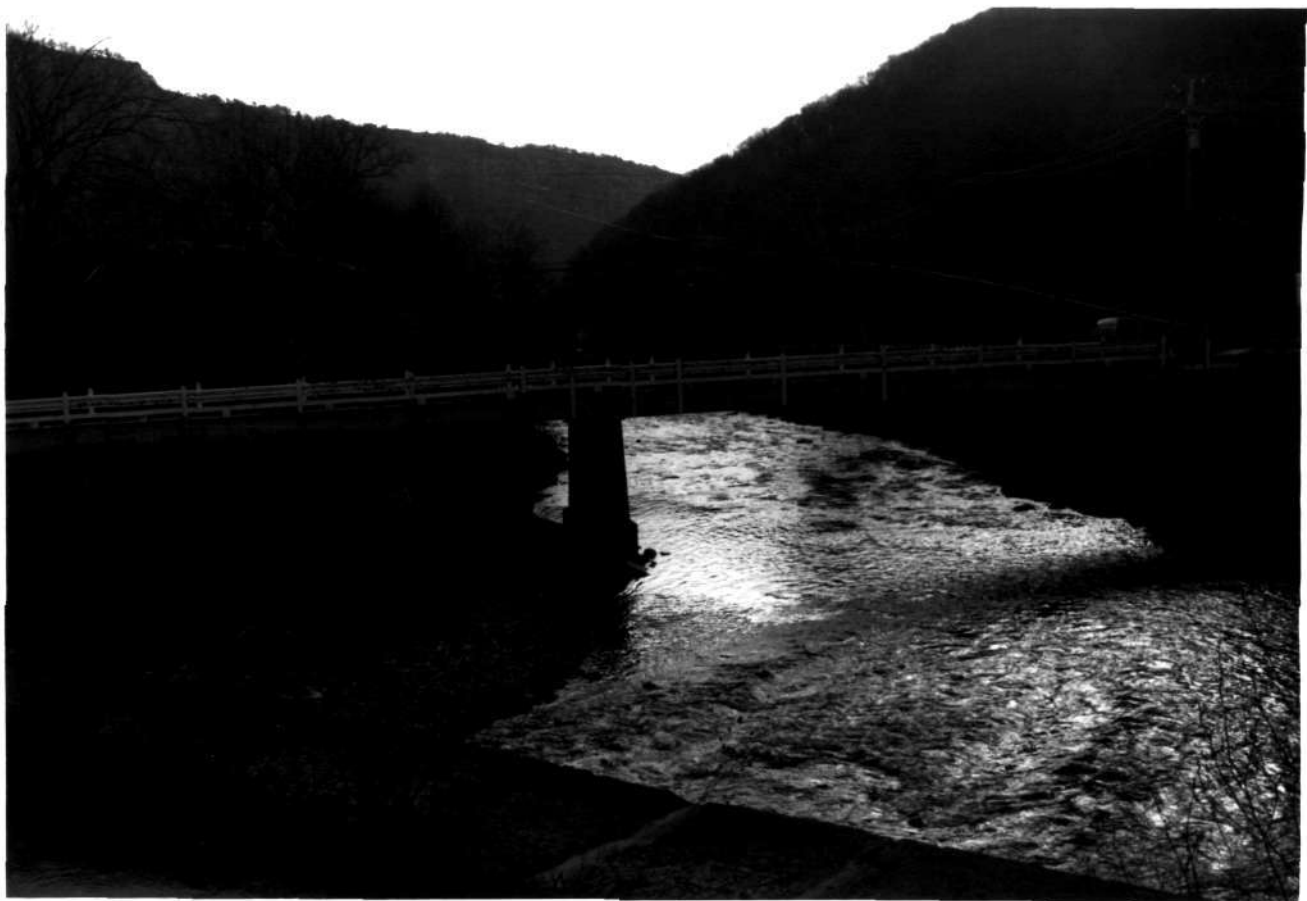
5 OF 5

SOUTH ELEVATION (UPSTREAM)
